Initial Inspection Report

Condominium Association Name	Regal Palms Condominium Association Inc	Case Identification No.	BW45EN4ZXA
Inspection Site Building Address	3400 Springdale Boulevard, Palm Springs, FL 33461	Building Identification No.	A5E08E2350
WCE	InterNACHI	WCE Inspector	Tracy Scully
On-Site Building Inspection Start Time	04/16/2025 09:00am	On-Site Building Inspection Completion Time	04/16/2025 04:00pm

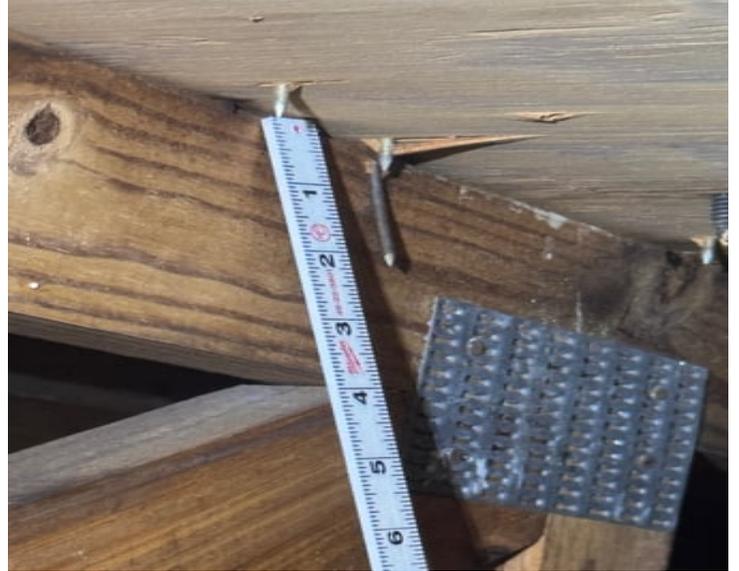
8d nails

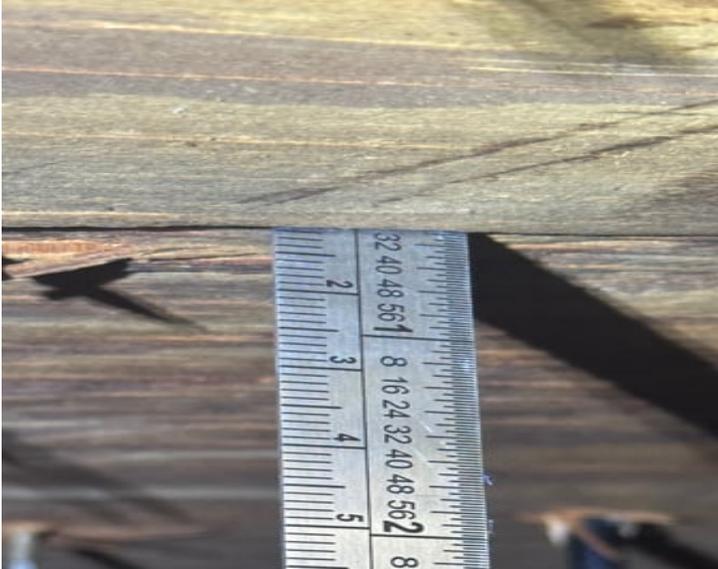
decking thickness

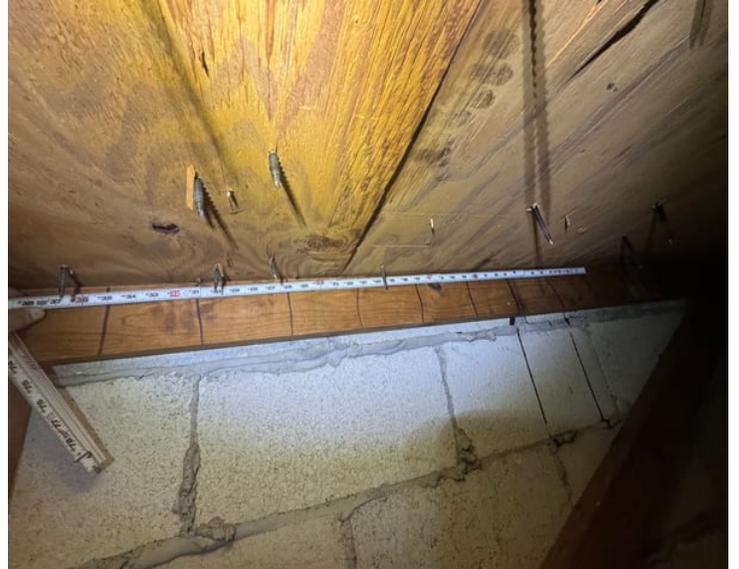
spacing edge

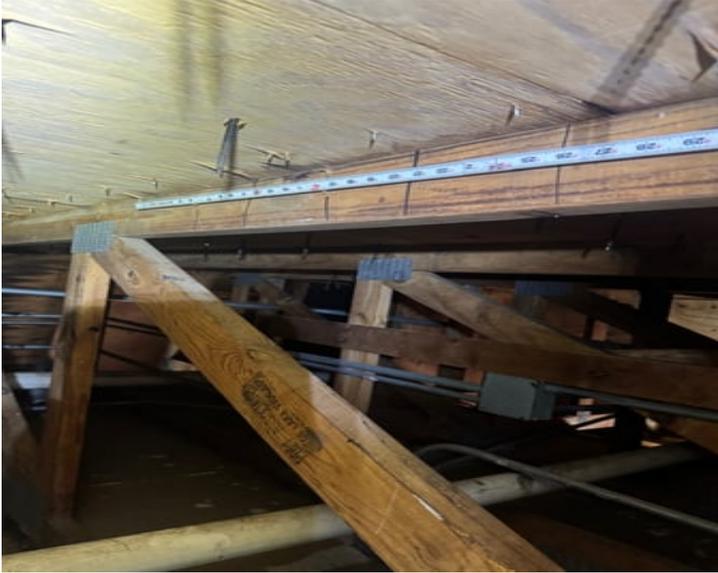
spacing field

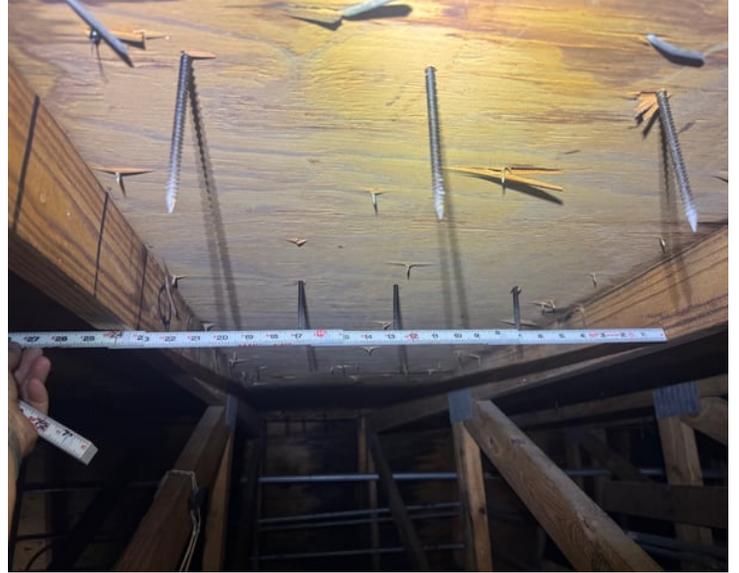
spaced w/i 24" oc

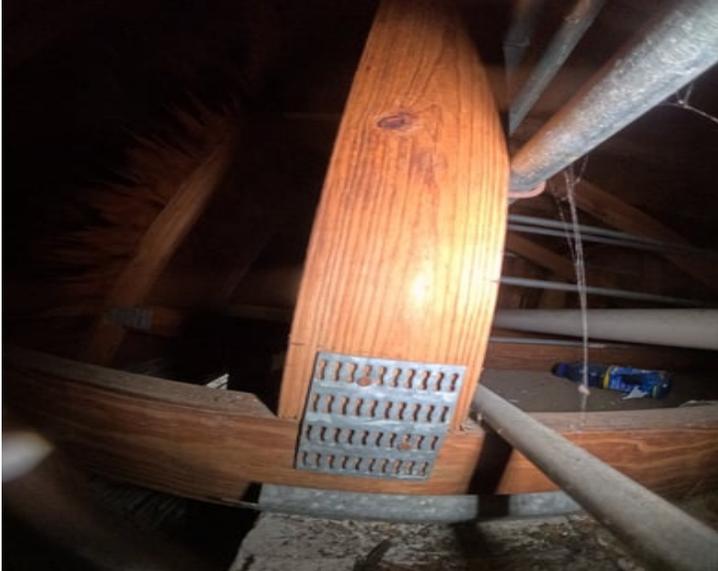
#1 toe nail- opposing side

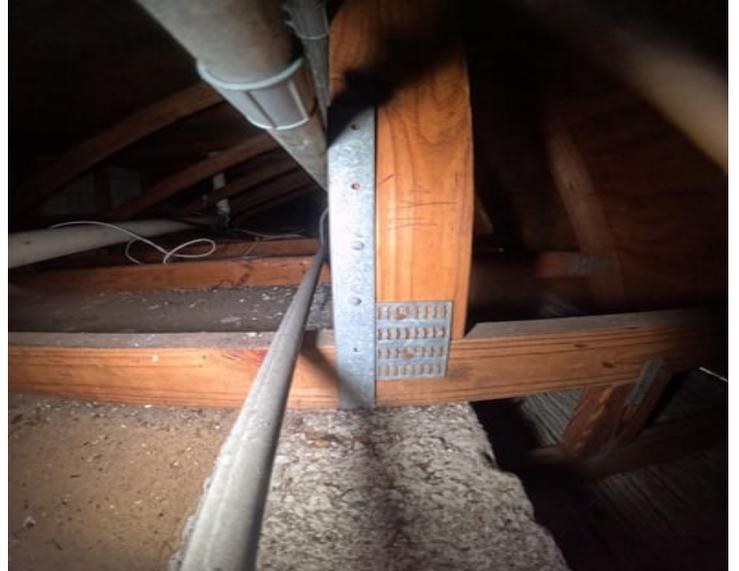
#1 toe nail front side 2 nails

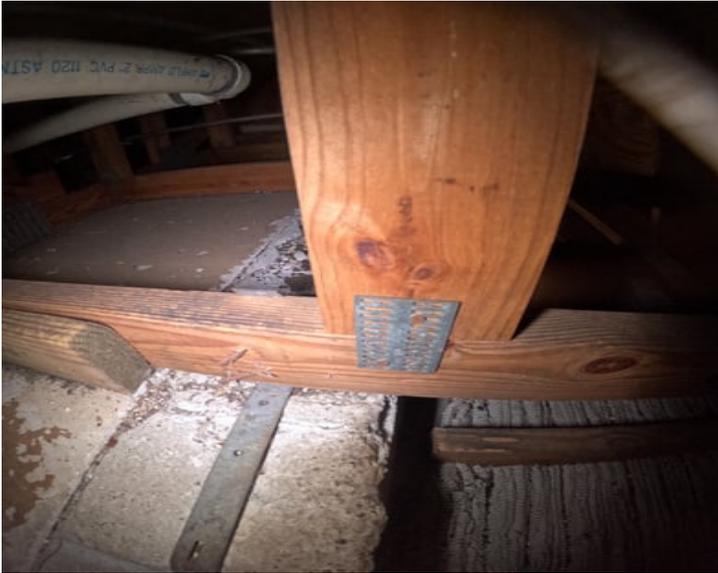
#2 toe nail top side

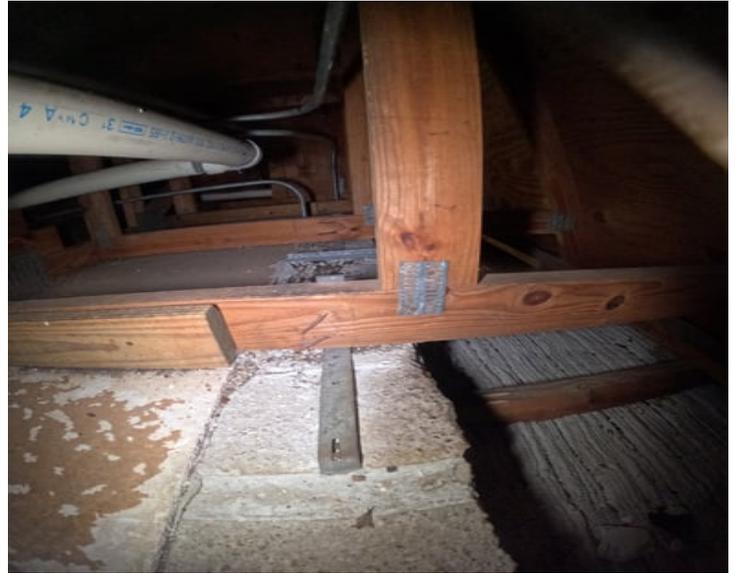
#2 toe nail: front side embedded with over 1/2" gap and goes under the truss

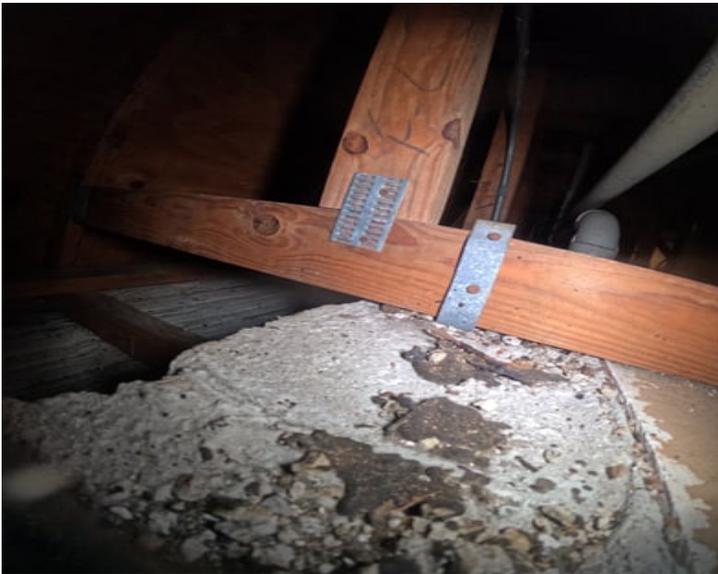
#2 toe nail: opposing side 2 nails

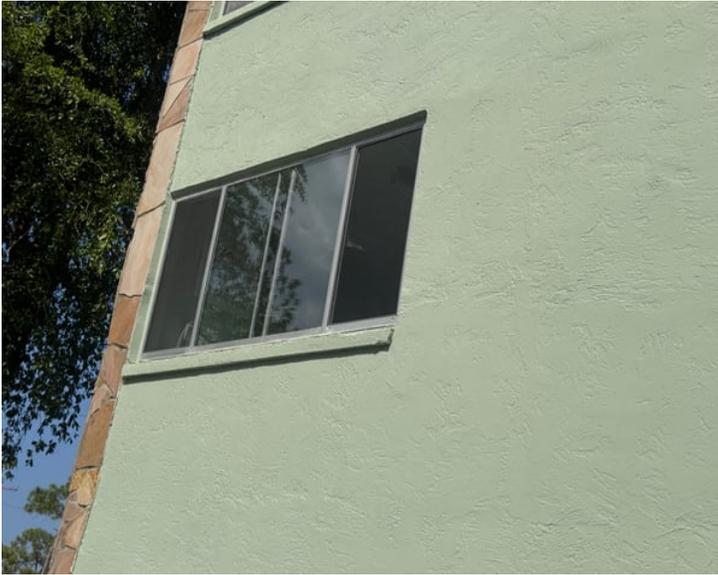
Stories 1-3 - Common Areas: Glazed (Protection Level-X)

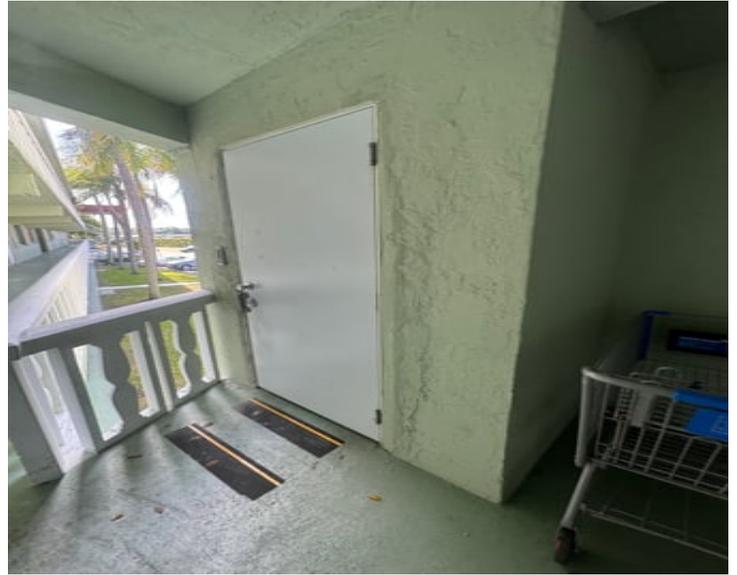
Stories 1-3 - Common Areas: Non glazed (Protection Level-X)

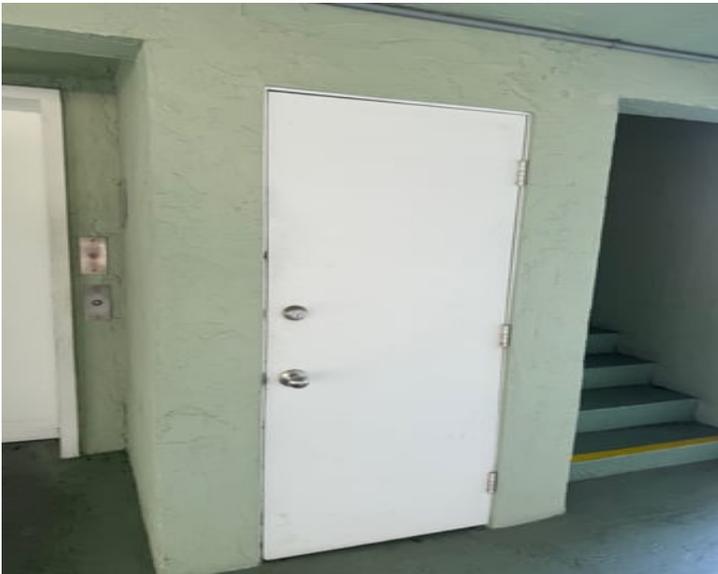
Stories 1-3 - Common Areas: Non glazed (Protection Level-X)

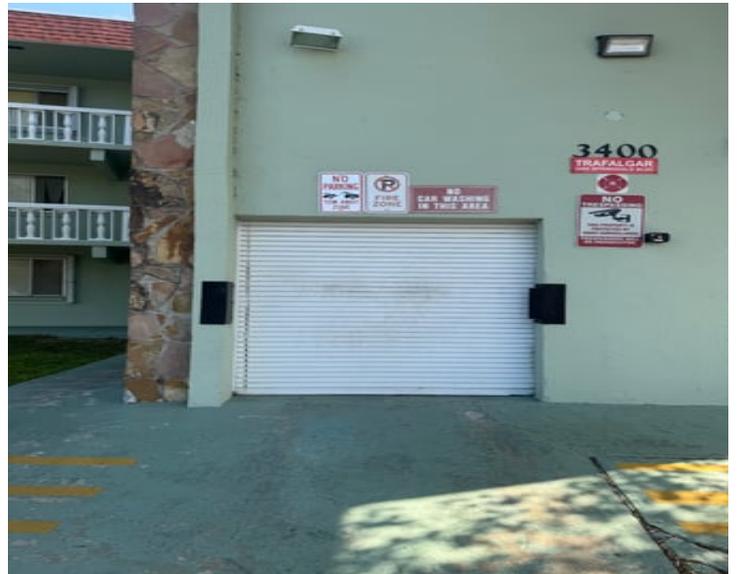
Stories 1-3 - Common Areas: Non glazed (Protection Level-X)

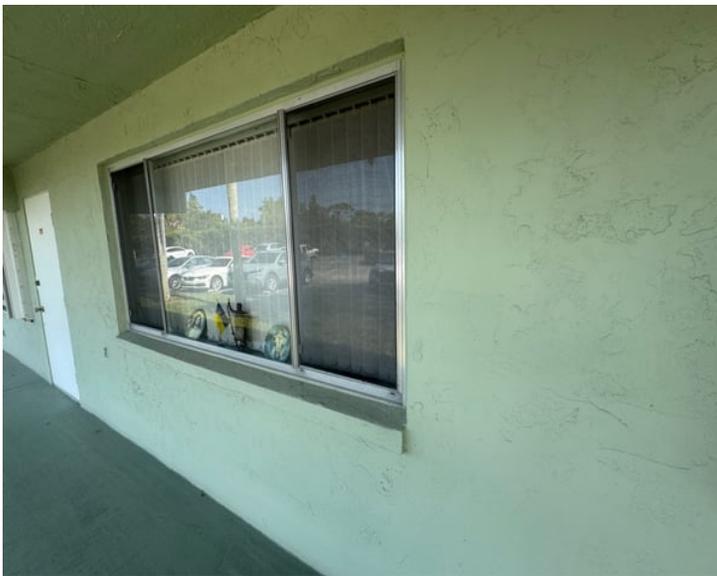
Stories 1-3 - Units: Glazed (Protection Level-X)

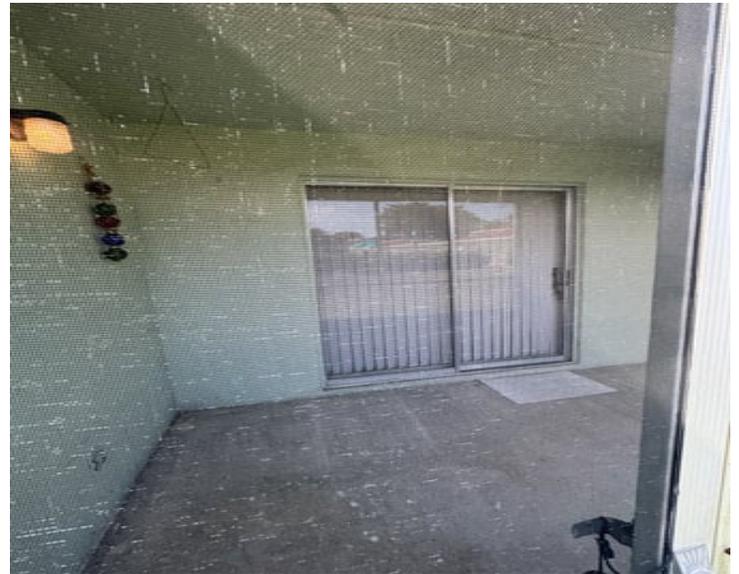
Stories 1-3 - Units: Glazed (Protection Level-X)

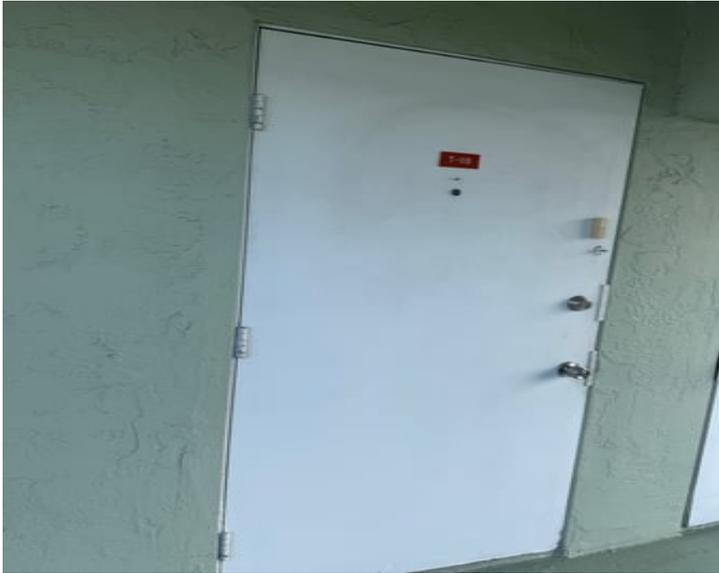
Stories 1-3 - Units: Non glazed (Protection Level-X)

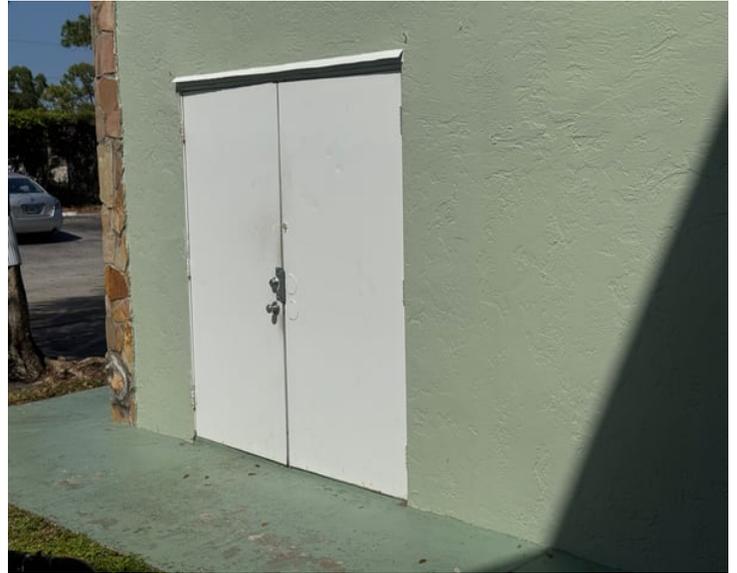
Stories 1-3 - Common Areas: Non glazed (Protection Level-X)

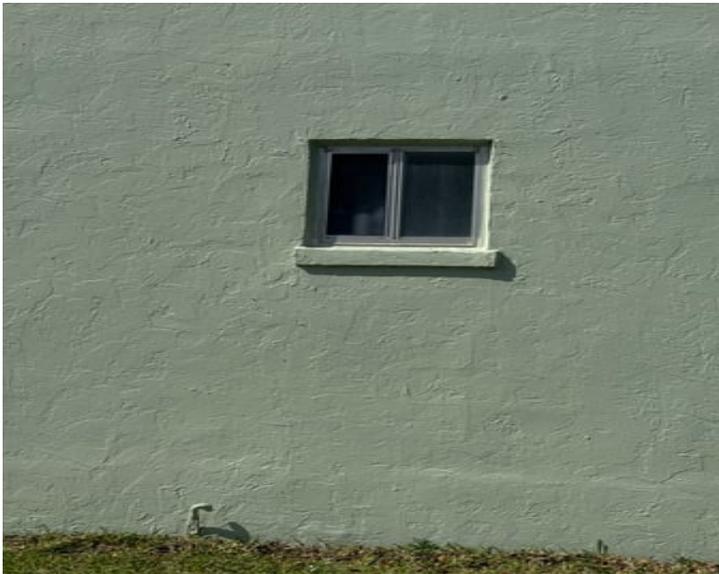
Stories 1-3 - Units: Glazed (Protection Level-X)

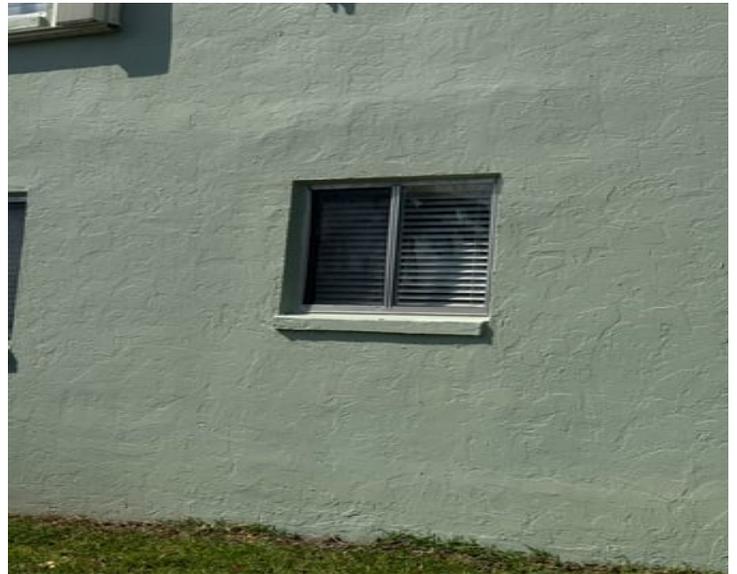
Stories 1-3 - Units: Glazed (Protection Level-X)
