STRUCTURAL INTEGRITY RESERVE STUDY

Regal Palms Condominium Association
3500 Springdale Boulevard
Palm Springs, Florida 33461

Project Number 2326162

February 28, 2024

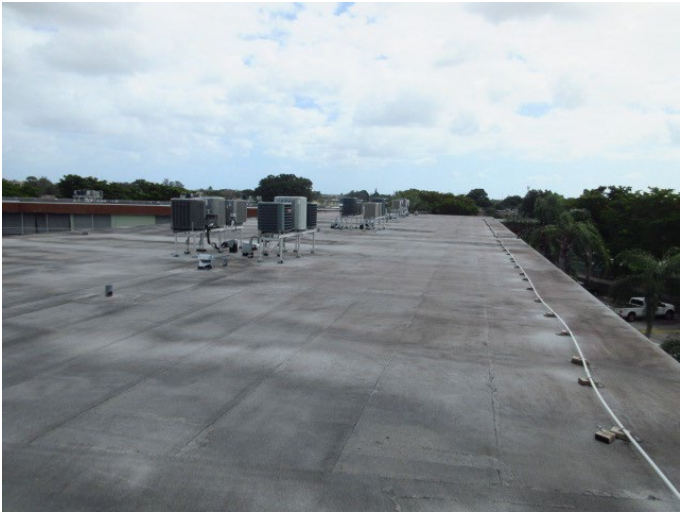
PHOTO 7

GENERAL VIEW OF ROOF COVERING

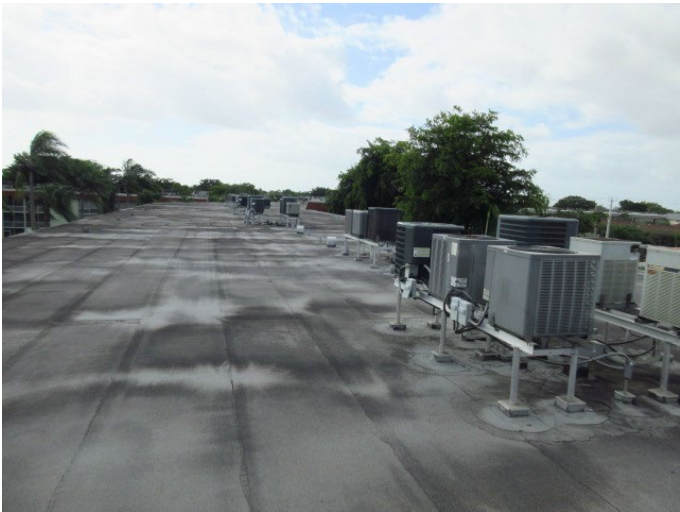
PHOTO 8

GENERAL VIEW OF ROOF COVERING

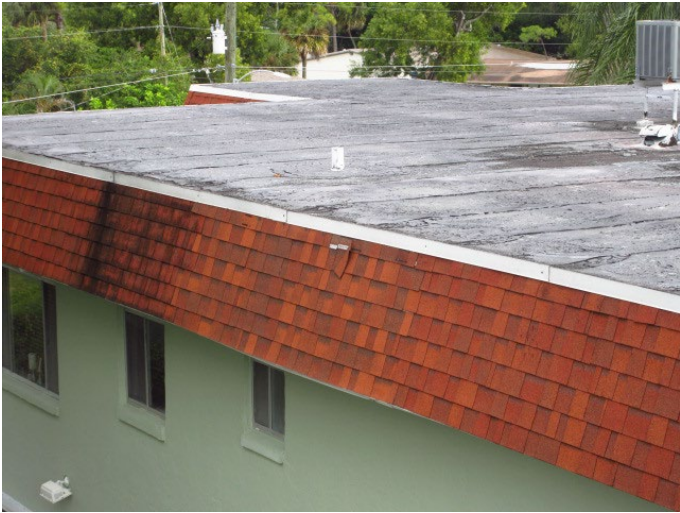
PHOTO 9

VIEW OF MANSARD SYSTEM

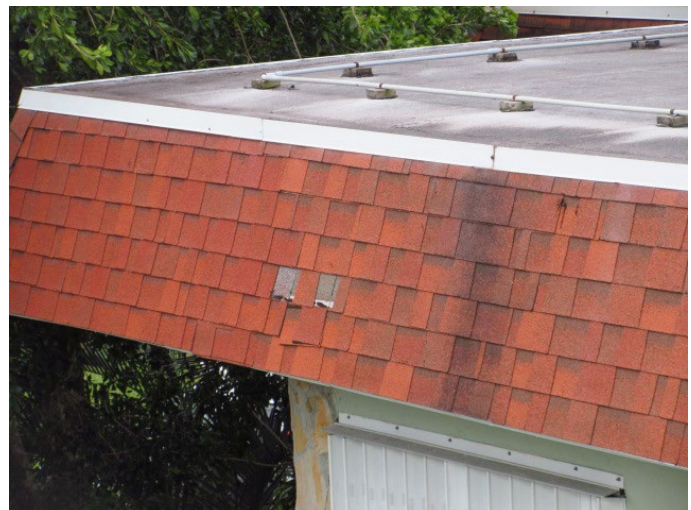
PHOTO 18

Item	Description/Observations/Comments
	<p>The roofs and mansards were noted to vary in age. Several damaged areas were noted within the older roofs and mansards, however, no active leaks were noted or reported. Modified bitumen roofs have an EUL of 20 years. Composition shingle mansards have an EUL of 30 years. Based on the apparent age of the roofs and conditions observed, phased replacement is recommended over the evaluation period. Funds have been allocated throughout the reserve period, adopting the straight-line accounting method to ensure the availability of funds at the end of the element's EUL, beyond the evaluation period of this assessment.</p> <p>Please note that the extent of the roof evaluation did not include sampling or testing, therefore comments made regarding the condition of the roof are limited to visual observation as well as historical information provided by site contact. Should a more comprehensive investigation be required, the services of a certified roofing consultant should be considered.</p>

VIEW OF DAMAGED / . MISSING MANSARD SHINGLES

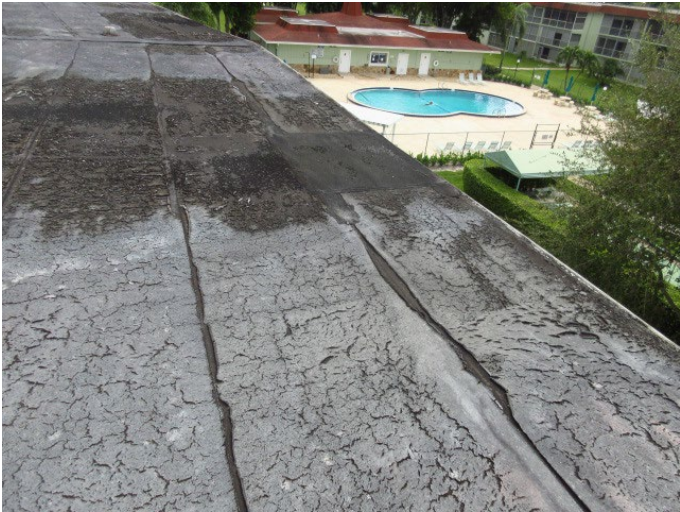
PHOTO 19

VIEW OF FAILING ROOF MEMBRANB

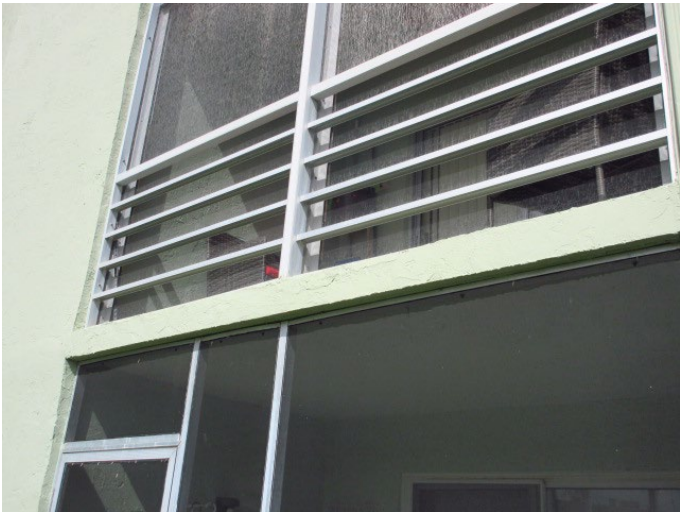
PHOTO 20

VIEW OF CRACKS AT BALCONY DECKING

Item No.	Item Description	Quantity	Unit	Cost	Totals	Existing Balance	Remaining Funds	Comments
1	Superstructure repairs	1	LS	\$20,000.00	\$20,000			Repair damages on exterior walls, walkways and balconies
					Subtotal	\$550,643.77	\$530,643.77	
					Total Immediate Repairs			
					Cost Per Unit

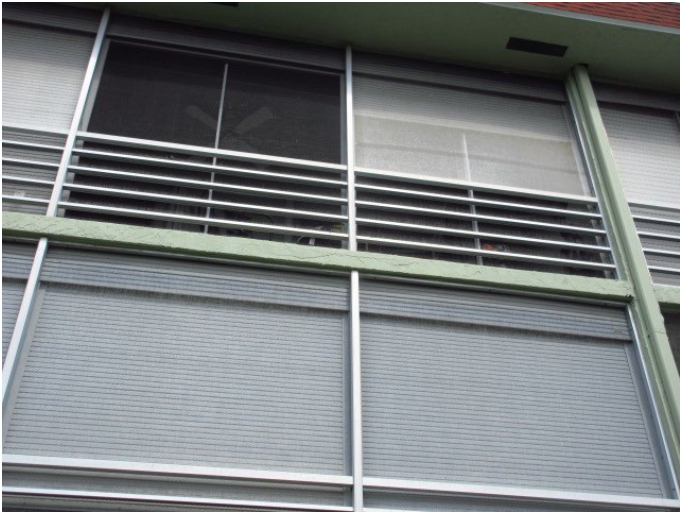
PHOTO 21

VIEW OF CRACKS AT BALCONY DECKING

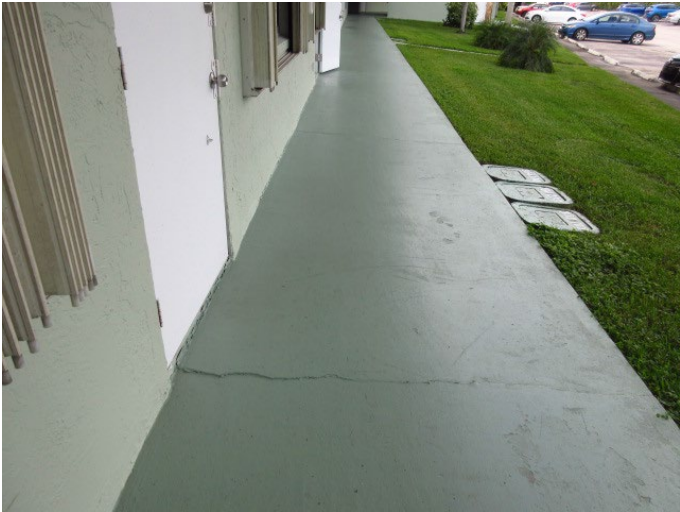
PHOTO 22

VIEW OF CRACKS AT GROUND LEVEL WALKWAY

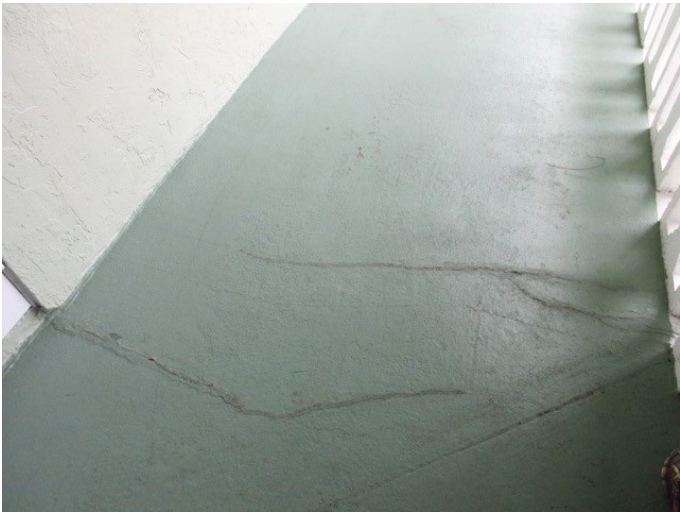
PHOTO 23

VIEW OF CRACKS AT ELEVATED WALKWAY

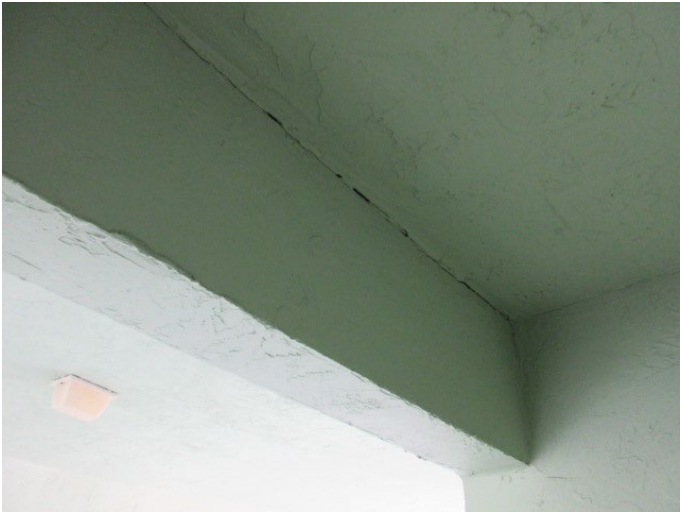
PHOTO 24

VIEW OF CRACKS AT SLAB UNDERSIDE
